A COST-EFFECTIVE SITE-SPECIFIC STRUCTURAL INVENTORY AND DECISION MAKING: HOW TO ACHIEVE IN ROAD REHABILITATION PROJECT

Shariful Malik*

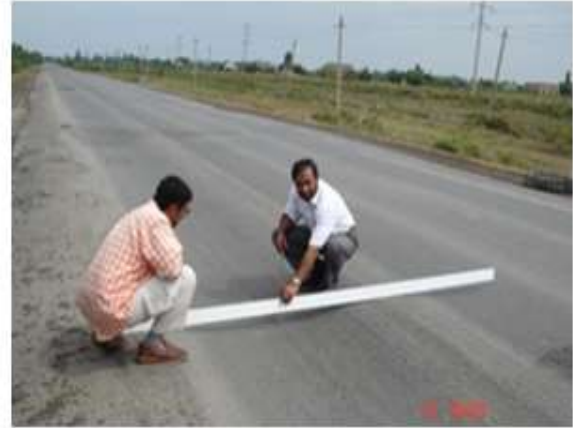
Figure 2: 70 mm deep rutting along wheel track, km 1+600, Source: from the project file

The depression/rut depth was found varying from 25 to 70 mm, with an average of 50 mm. The surface was badly cracked and undulated. The crack widths measured and found greater than 3 mm, with an average of 10 mm. The cracked surface represents about 30 to 50 % of the paved area. The riding quality was inferior. A comfortable ride at a speed greater than 40 km/hr was practically impossible. The standard pavement crown diminished in almost all stretches. With respect to the International Roughness Index (IRI) having scale 0 ~ 10, the existing pavement surface had an estimated IRI > 7.

In a rating of 0 to 5 (0 being the worst and 5 being the best) the present serviceability index of the existing pavement condition had an estimated value of less than 2.5. So the pavement of all overlay sections had reached to its terminal serviceability condition, which badly warrants reconstruction instead of overlaying.

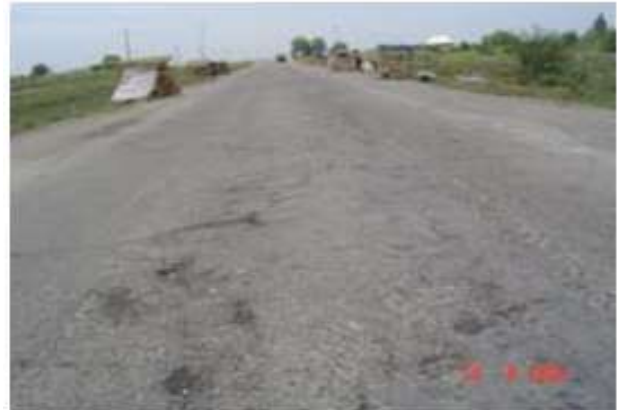
Figure 3: Cracked and undulated surface at Km 25, Source: from the project file

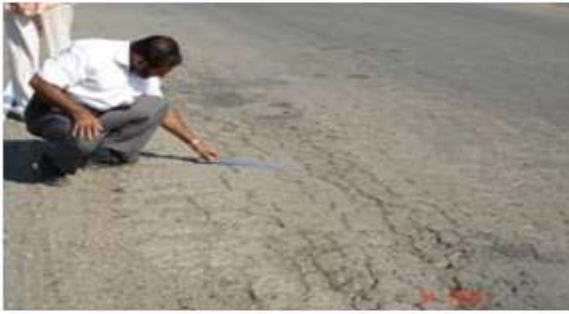
Figure 4: 3 ~ 15 mm wide crocodile cracks at km 7+700,
Source: from the project file

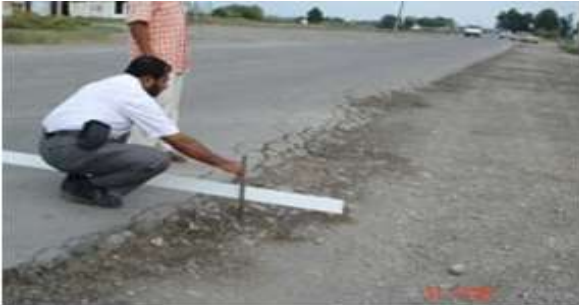
Figure 5: Shoulder erosion and edge failure at km 8+200,
Source: from the project file
