INFLUENCE OF HARDNESS PROFILE ON FATIGUE FAILURES OF CASE HARDENED RACES

Matjaž Torkar, Bojan Podgornik, Franc Tehovnik
 Institute of Metals and Technology, Ljubljana, Slovenia

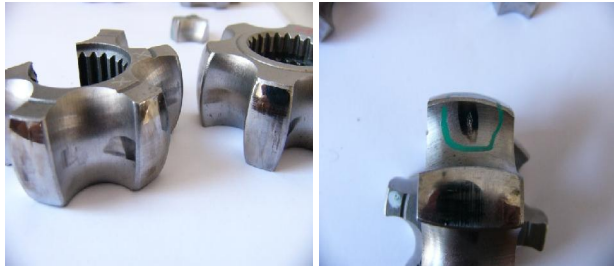
Fig. 2 Traces of wear after the test on the surface of: a) Race 1 and b) Race 2

A Visual inspection of the races (Figure 2) revealed traces of wear and flakes observed on the surface of the race.

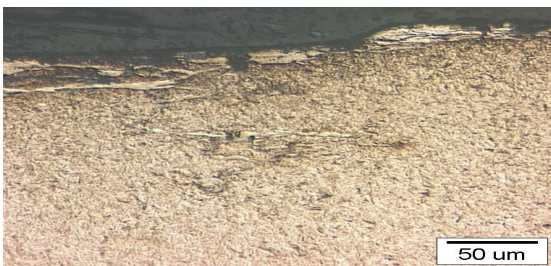
Metallography revealed the presence of fatigue cracks (Figure 3, 4) below the surface of the race at both components. It is evident that the sub-surface cracks and flaking of the surface was caused by Hertz's stresses.

Fig. 3 Cross section of Race 1 with higher hardness of surface, after durability test. The white fields represent plastically deformed martensite and/or rests of fretting corrosion on the loaded area.

The race with higher hardness of case hardened layer (Figure 6) had flakes on the surface (Figure 3) which was not the case at the race with lower hardness of case hardened layer (Figure 4). We suppose the reason is in softer

The cracks appear below the surface to the depth of 0.2 mm at Race 1 and some cracks were connected with the surface of the race, where the flaking of the surface was observed.

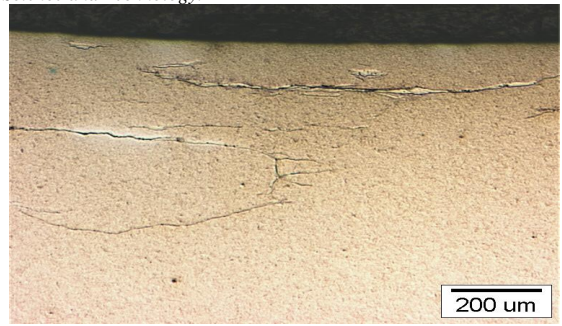
Fig. 4 Cross section with cracks below the softer surface of Race 2, after durability test. Contact fatigue cracks propagating parallel to the loaded area.

No flaking of the raceway of the Race 2 was observed, despite the presence of the internal cracks below the surface, to the depth of 0.5 mm. Lower hardness of case hardened layer means better ductility of material that hinders the crack grow and propagation. In both races the cracks are first parallel to the surface and surrounded by deformed martensite (Figure 4). Deformed martensite with the hardness of 1076 HV was present only below the contact point in the race. Out of the contact region, no cracks and no deformed martensite was observed.

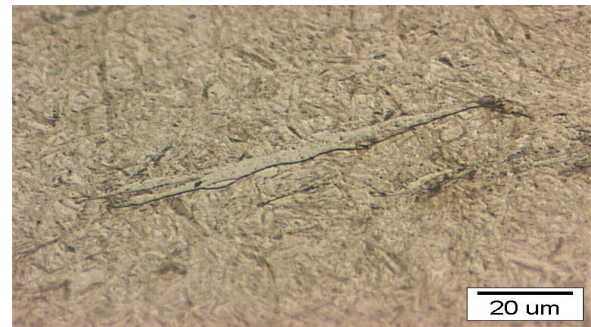
Fig. 5 Plastically deformed martensite with hardness 1076 HV 0.025, about 0.1 mm below the surface of Race 2

Metallography revealed in both racers the brighter kneaded layers near the cracks, as presented for race 2 in (Figure 5). The measurements of hardness in both components confirmed that brighter areas near the cracks represent deformed martensite, with the hardness of 1140 HV 0.2 at Race 1 and a little softer deformed martensite with 1074 HV 0.2 at Race 2. Fretting corrosion [14, 15] or degradation of grease [16] are two possible causes of white layers on the surface of the race 1. Fretting corrosion is typical at slow moving surfaces under high local pressure resulting in high local temperatures and degradation of grease. Beside that specific local pressure and slow moving increase the temperature at the contact point above the temperature of transformation of martensite to austenite. In such a case the white austenite layer is formed. White austenite layer has lower hardness than material around it. In specific cases the hardness can increase due deformation strengthening during the local kneading of material.

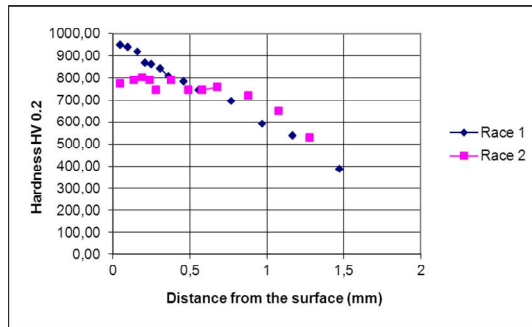
The profile of hardness HV 0.2 through the case hardened layer was measured at both races on a not damaged surface. Based on criteria HV 550 the thickness of case hardened layer at both races was around 1.2 mm.

The races differ only in hardness near the surface of case hardened layer (Figure 6). This confirmed that both inner races have not been case hardened in the same conditions.

Fig. 6 Hardness profile in case hardened layer of Race 1 and Race 2

Microstructure of the base material, below the case hardened layer is presented in Fig. 9 and 10. Both races have identical base microstructure. The races were tested in similar conditions with the same lubricant. The only possible reason for observed failures is the difference of hardness profile in case hardened layer of the races.

For better endurance of investigated races the hardness and the thickness of case hardened layer should be adjusted, according to position of Hertz's stress concentration below the surface of the raceway, already at planning of manufacturing process of the race.

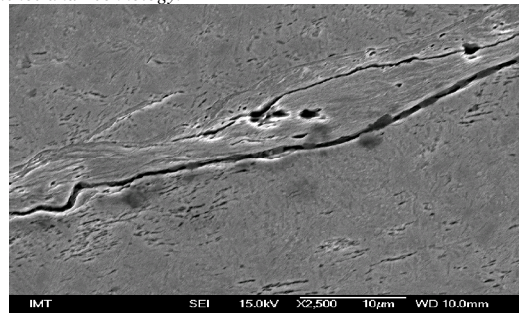
Fig. 7 Sub-surface crack surrounded by plastically deformed martensite in Race 1. (SEM)

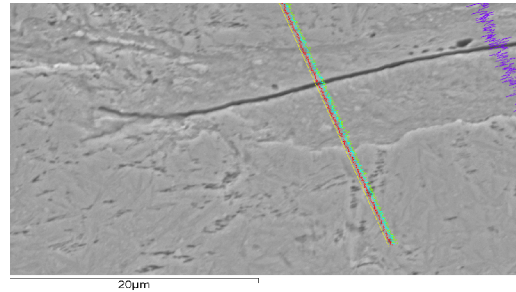
SEM observations and the EDS line analysis were performed across the crack and deformed martensite layer to reveal the possible differences in chemical compositions as for instance the segregations. EDS line analysis did not reveal any change in concentration of analysed elements, C, Cr and Mn. The white layers therefore represent deformed martensite with the same chemical composition as base material (Figure 7 and 8).

Fig. 8 Line analysis of C, Cr, Mn across the fatigue crack and deformed martensite layer in the Race 1. No segregations are present. (EDS)

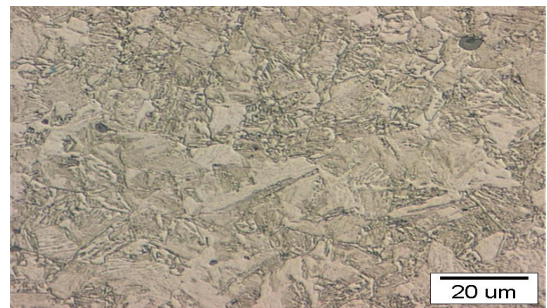
Fig. 9 Microstructure below the case hardened layer of Race 1

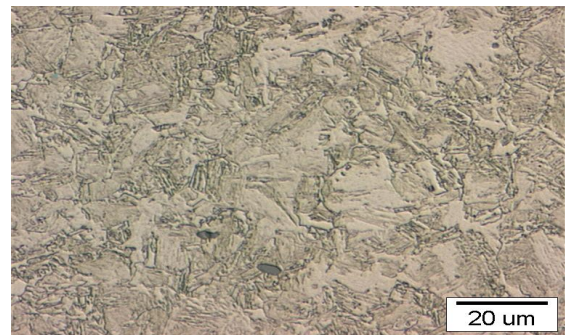
Fig. 10 Microstructure below the case hardened layer of Race 2
