A COMPREHENSIVE AND QUANTITATIVE GEOTECHNICAL AND PAVEMENT INVESTIGATION FOR GREENFIELD URBAN ROAD DEVELOPMENT IN PERTH, WESTERN AUSTRALIA

Shariful Malik*, Mohammad Amzad Hossain

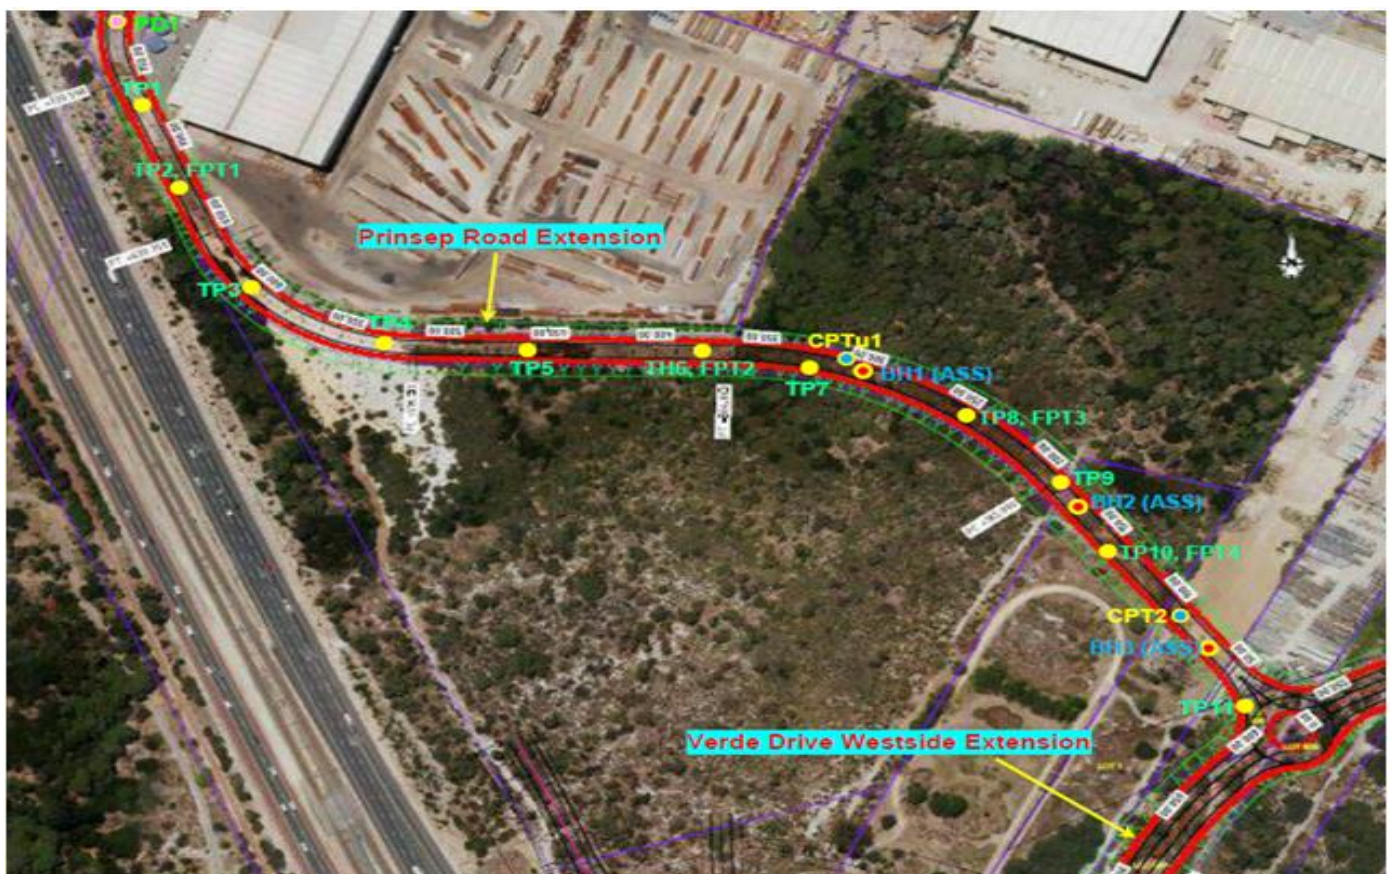
Figure 7: Geotechnical and Pavement Investigation for Prinsep Road extension

Site Plan: Test Pit (TP), Cone Penetration Test (CPT), Bore Hole (BH) for ASS and Field Infiltration Test (FPT) Locations

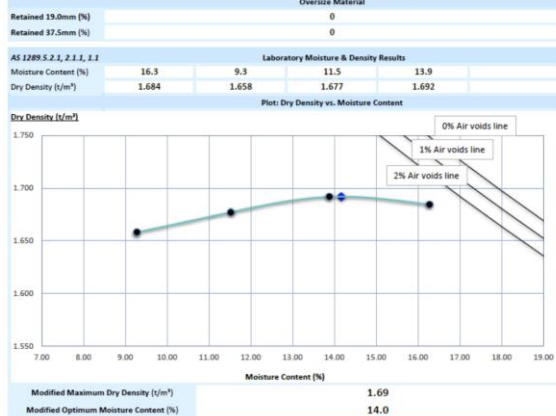
Figure 142: Max dry density and moisture content at TP4 (Verde Dr.)

Comments: The above air void lines are derived from a calculated apparent particle density of 2.644 t/m³
