TOWARDS QUALITY DECISION MAKING FOR SUBSOIL INVESTIGATION; SITE CLASS AND POTENTIAL SURFACE MOVEMENT RESULTANTS CRACKING BUILDINGS IN PERTH, WESTERN AUSTRALIA

Abstract: The issues impacting the modern buildings cracking have many folds ranging from physical attributes to geological factors. The literature reveals that the expansive soil is widely spread all over Australia that causes great anxiety in house owners and technical industries for sustainable building development, protecting structural failure based on sound structural and geotechnical principles (Sun et al., 2017 p. 3960). To mitigate these nationwide challenges, a national standard, AS2870, was established in 1986 to provide a guide for the building industry (AS 1996, p.7). Although a standard was adopted, quality decision making is inevitable along with this Standard for the best outcome that promotes a comprehensive outlook in envisaging safety measures. Nonetheless, To accommodate an extra 1 million population by 2050, targeting 50% urban infill, the Perth Metropolitan Area has enormous pressure on releases new urban buildings and corridors (WAPC, 2010). Moreover, due to the current Pandemic, Australian Federal Gov

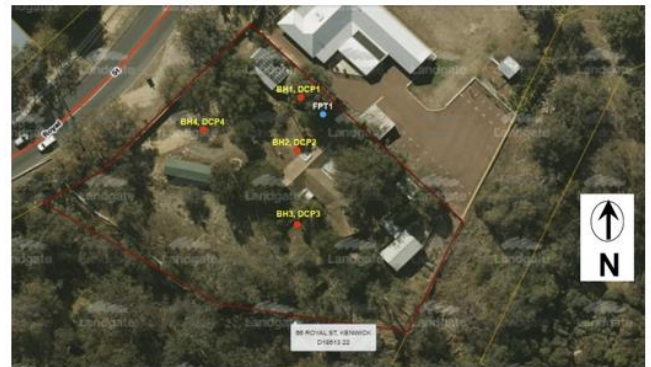
Figure 6: Location of Lot 22 (66) Royal Street, Kenwick WA City of Gosnells, South East Metropolitan Tests Locations: Bore Hole (BH), Dynamic Cone Penetration (DCP) and Field Permeability Test (FPT)

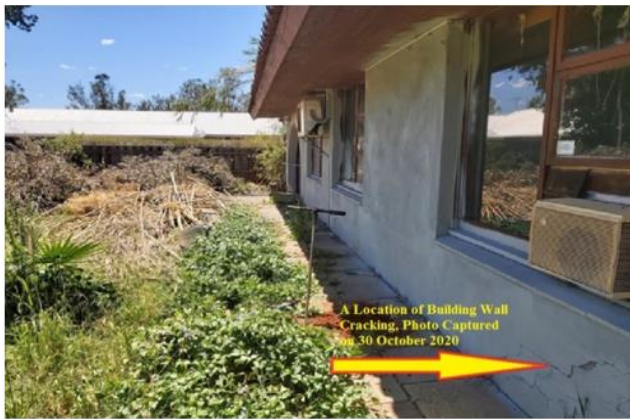
FIGURE 8: A LOCATION OF EXISTING BUILDING CRACKS

A review of Landgate Information and aerial photography of the site indicates that the site is situated in a residential area. Royal Street bounds the site at the northern side, Canning river at the western and southern side, Gospel Methodist Church and bushland at the eastern side. Currently, there is an existing house and few sheds at the site. Few cracks were observed in the existing house wall at the time of the investigation. There are some small to big size trees at the site. The site level is found flat at the northern and eastern side, and the western and southern side slopes up to Canning River. Geomatics Australia conducted a topographic Survey (Feature Survey) on 8 October 2020, tying with Perth Coastal Grid (PCG94) projection linking to Australian Height Datum (AHD). The site photograph was taken during the field investigation are shown in figure 7 and 8 below.

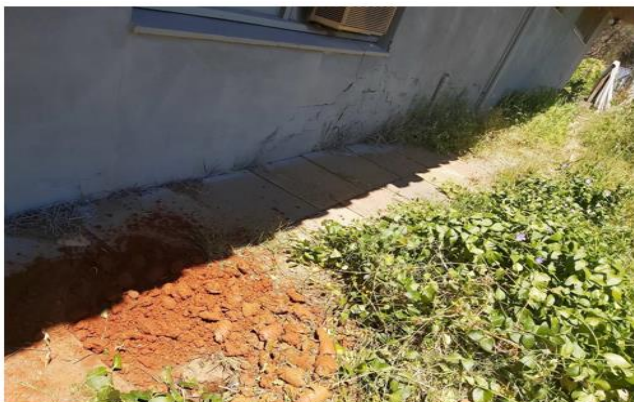
Figure 9: Type of Soil observed from test pit

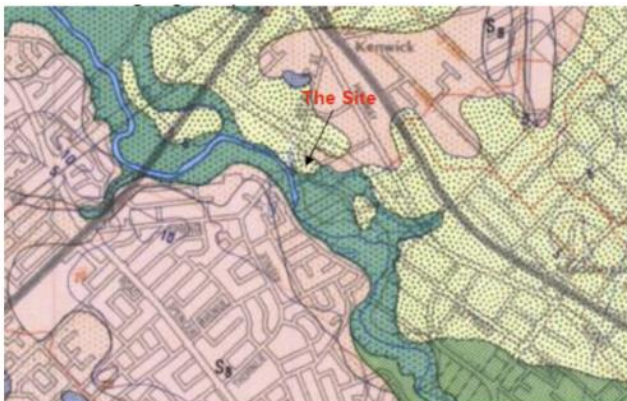
FIGURE 10: GEOLOGICAL MAP

A review of Environmental Geological Western Australia survey Map of Armadale 1:50,000 (part sheets 2033 I and 2133 IV) revealed that the site consists of Sandy Clay- white grey to brown, fine to coarse-grained, sub-angular to rounded sand, clay of moderate plasticity, gravel and silt layers near scarp, Guildford formation. The Environmental Geological Map of Armadale also revealed that the site soil has low permeability, Low corrosion potential, low to medium slope stability, low bearing capacity. Sand pads are required beneath foundations, and high logs may require pile support, permanent cuts unstable, prone to seasonal flooding, interferers with Sc to west and colluvium to east.

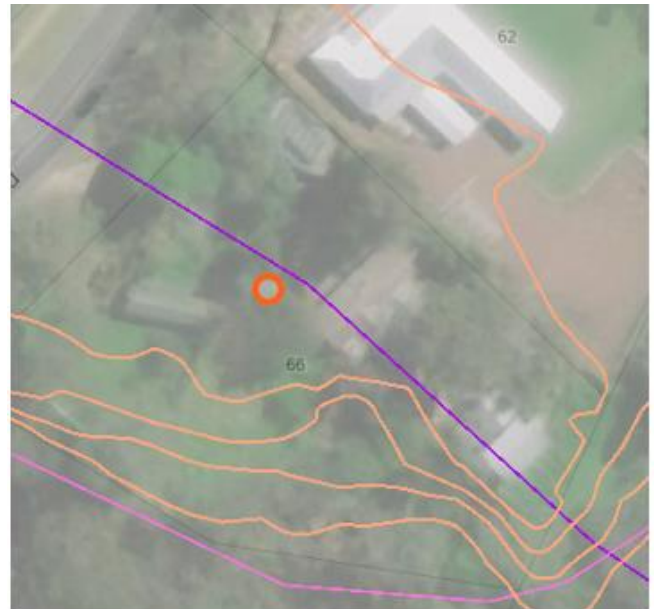
Depth from ground level to:	
Watertable:	2.8 meters
Base of Aquifer:	13.8 meters
<hr/>	
Levels relative to AHD (~sealevel)	
Natural Surface:	3.8 meters
Watertable:	1.0 meters
Base of Aquifer:	-10.0 meters

Groundwater Salinity	1000-1500 mg/L
Surface Geology Type	Guildford Clay: alluvium (clay, loam, sand and gravel) Qpg
Iron Staining Risk	Low risk
Garden Bore Suitability	Unsuitable
Acid Sulfate Class	Moderate to low risk
Public Drinking Water Source Areas (PDWSA)	N/A

Figure 11: Groundwater Information from Perth Groundwater Atlas

The groundwater table was not observed at any of the boreholes up to the investigation depth of 2.0 m. A review of the ‘Online Perth Groundwater Atlas’ of the Department of Water was carried out for this site. ‘Perth Groundwater Atlas’ revealed that natural surface elevation is 3.8 m AHD and the annual average groundwater table is at 1.0 m AHD. That means the depth of the groundwater table is approximately 2.8 m AHD from the ground level. The groundwater level contours are estimated based on the recorded groundwater levels measured in May of 2003 (end of summer).
