# MODERN INTERVENTION METHODS FOR CONSOLIDATING THE MASONRY STRUCTURES

*Abstract - The paper presents an experimental program to determine the influence of reinforced masonry made with the carbon fibres. In order to ensure the characteristics needed for reinforced masonry to be used in the Vrancea seismic zone, a program for reinforcing the masonry was developed. The main objective of the program presented in the paper is to reveal the contribution of the reinforcement with carbon fibre to the ductility performance, of the masonry. A part of the program was developed to evaluate the influence of carbon fibre on the mechanical characteristic of masonry made with type 2S bricks with vertical gaps used in the current practice and with solid bricks.*

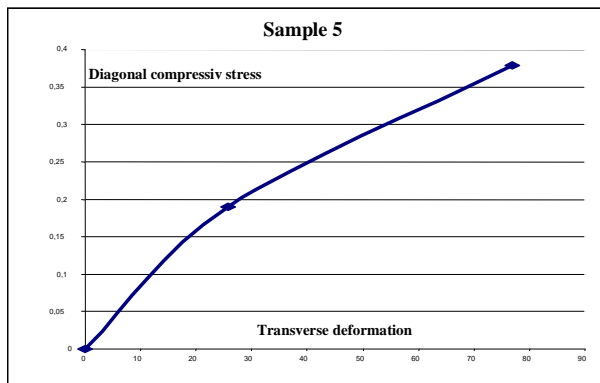
**Figure 2.** Reinforced sample diagram: a) sample 4; b) sample 5 (according to the table 1)

In the case of the samples 4 and 5, was notice an increase of the capacity to resist stresses (with at least 75% more compared to the non-reinforced samples in the case of using the consolidation method on both sides of the sample, with three lamellas positioned parallel with the diagonal and at least 20% in the case of using the consolidation method on both sides of the sample, with two lamellas positioned parallel with the joints) as well as a considerable increase of the deformation (almost double in the case of sample 5 and more than three times in the case of sample 4).

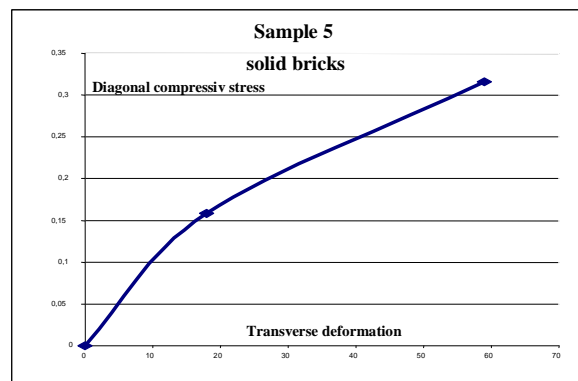
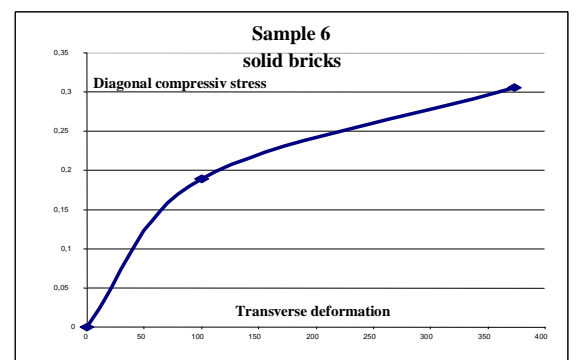
**Figure 3** The stress-deformation diagram for solid bricks a) control sample; b) sample reinforced on one side; c) sample reinforced on both sides (according to table 2).

The samples 5 and 6 with the positioning of the lamellas on a single side, respectively on both sides, parallel with two sides of the masonry panel have shown an important increase of the deformation capability (double for the reinforcement on one side – sample 5 and ten times larger

for the reinforcement on both sides – sample 6). Both samples have failed by the detachment of the lamellas: in the central area in the case of sample 5 and at the ends in the case of sample 6.

a) the consolidation of the small sized masonry panels with carbon fibre lamellas, Carbodur type, certainly increases the panel capacity of deformation when are breaking. This thing can be clearly noticed from the diagrams from figure 3 a), b), c) drawn for the samples made out of solid bricks (the double deformation for the application on one side of the panel and 10 times larger deformation for the application on both sides of the panel);

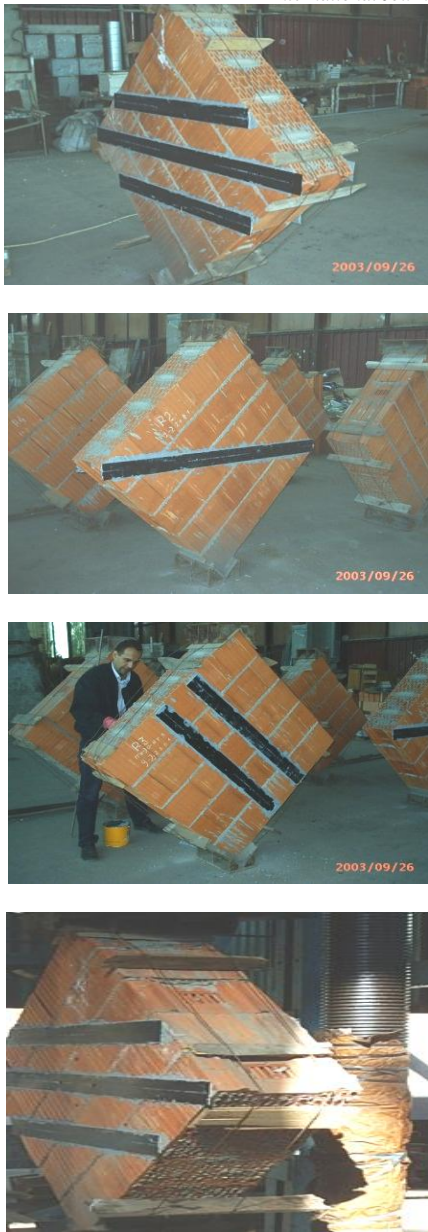
**Image 1** Marking the position of the lamellas

The positioning of the Sika Carbodur S 1012 lamellas is shown in the image 1, for the samples made of type 2S bricks with vertical gaps and in the image 2, for the samples made with solid bricks.

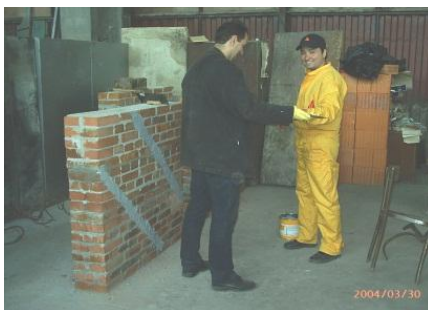
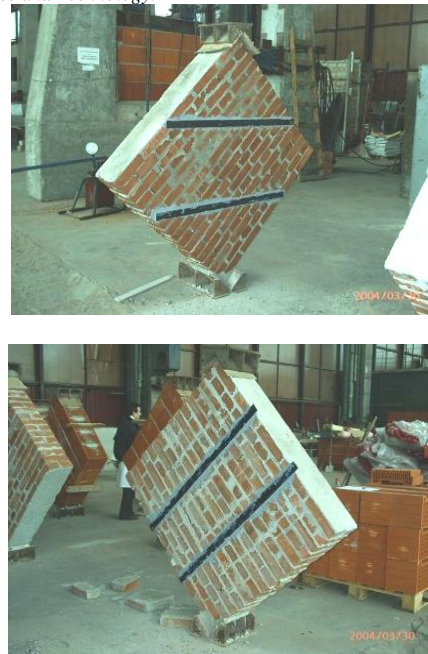
Samples made out of solid bricks

**Image 2** Sample made out of solid bricks prepared for reinforcement
